ANNUAL

REPORT

2015

Aviation Investigation Regulation

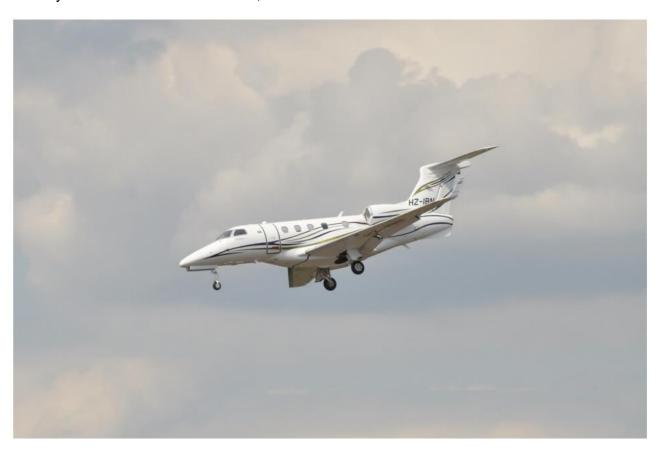
Fig.8 Embraer Phenom-505 aircraft- Preliminary Report, AAIB-UK

Embraer Phenom-505 aircraft (Fig.8) was on a private IFR flight from Milan, Italy, to Blackbushe, with the commander and three passengers on board. Following descent from its cruise level, it was handed over from controllers at London Control to Farnborough Approach. They provided a radar service to the aircraft, before instructing the pilot to contact Blackbushe Information, a few miles prior to its entry into the Blackbushe Aerodrome Traffic Zone. The weather at Blackbushe was fine with light and variable winds, visibility in excess of ten kilometres, and no low cloud.

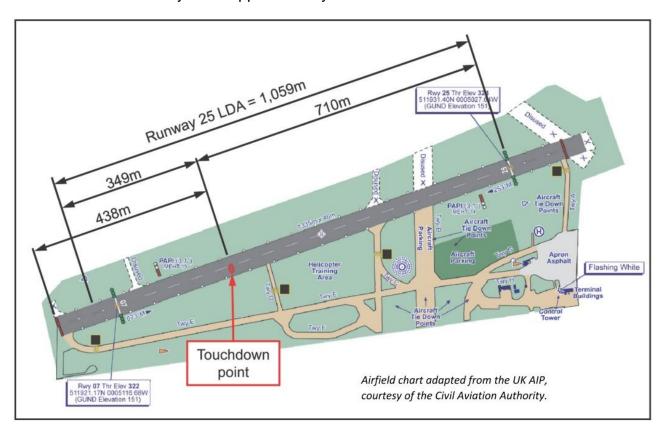
Fig. 9 Airfield chart Runway 25-Preliminary Report -AAIB-UK

Tyre marks made by the aircraft at touchdown indicated that it landed approximately 710 m beyond the Runway 25 threshold (Fig.9). Runway 25 has a declared Landing Distance Available (LDA) of 1,059 m; therefore the aircraft touched down approximately 349 m before the end of the declared LDA, 438 m before the end of the paved runway surface.

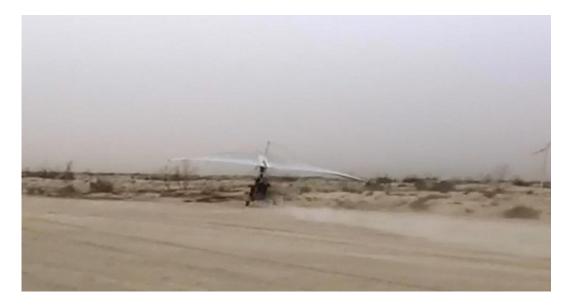
Fig. 11 Microlight aircraft take-off run-up in diagonal to runway-AIB Investigation Department

The pilot positioned the aircraft at the Sothern part of the field, applied full throttle and started to perform take off. For an unknown reason he elected to take a diagonal path in the field to perform the take-off and not to use the correct airstrip (East to West) to be against wind direction (Fig. 11).

- There was no evidence of technical failure of the aircraft that contributed to the accident.
- The aircraft take-off in the direction of cross winds.
- Takeoff roll did not utilize the full length of runway strip.

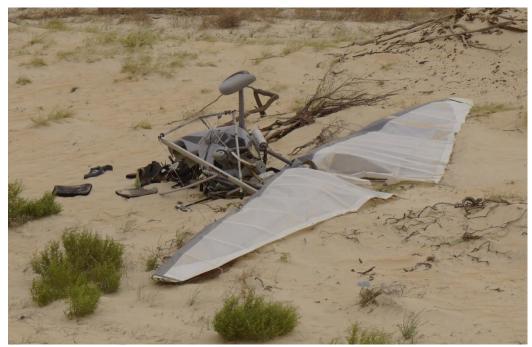
Fig. 12 Microlight aircraft after the accident-AIB Investigation Department

Due to the impact forces the cockpit and nose section of the aircraft were significantly disrupted and the damaging parts and the metal structure as shown in (Fig 12).

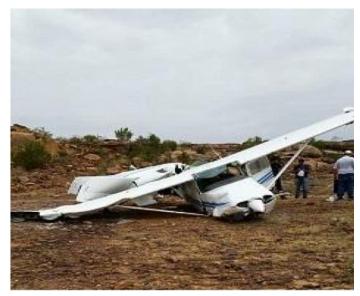
Fig. 14 Cessna 182N aircraft post-crash- Source : AIB Investigation Department

force landed on a flat spot in the mountainous terrain at approximately 1270 feet beyond the end of the runway.

The aircraft impacted the rocky terrain before it settled on the planned designated hard spot. The two occupants survived the accident with no reported injuries. The aircraft sustained substantial damage. (Fig 14) The Saudi Civil Defence unit and the local police arrived at the site approximately 30 minutes after event.
