2020 FIRST QUARTER REPORT

AVIATION INVESTIGATION BUREAU
KINGDOM OF SAUDI ARABIA

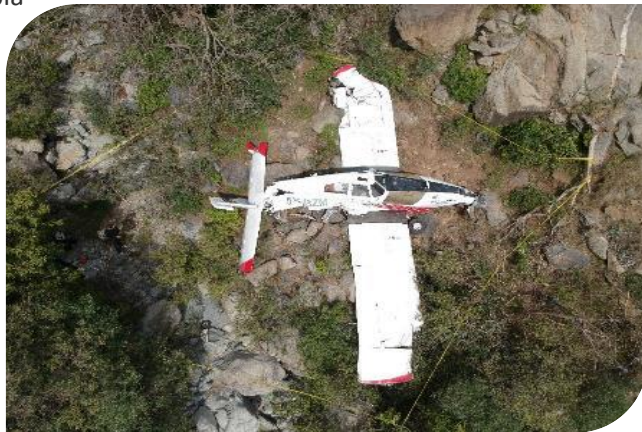
Figure 1 : 5Y-BZM collided into mountains

At approximately 11:08 on 10 February 2020, the Aviation Investigation Bureau (AIB) of Kingdom of Saudi Arabia was notified of a controlled flight and collision with terrain, involving a Thrush aircraft, registration 5Y-BZM, departing from Quz South Airport (OE48) to Sulayel Airport (OESL) in Saudi Arabia

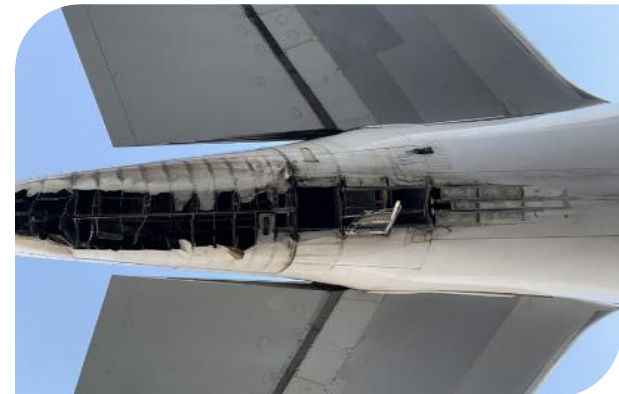
Figure 2: Tail strike damage

On 01 February 2020 at approximately 00:08, the Aviation Investigation Bureau (AIB) of the Kingdom of Saudi Arabia received a notification from Dammam airport authority of a B747-400F, registration TC-MCT, flight SVA919 had tail-strike while departing from King Fahd International Airport (OEDF), Dammam, Saudi Arabia to Zaragoza Airport (LEZG), Spain and diverted to King Abdulaziz International Airport (OEJN) Jeddah, Saudi Arabia.

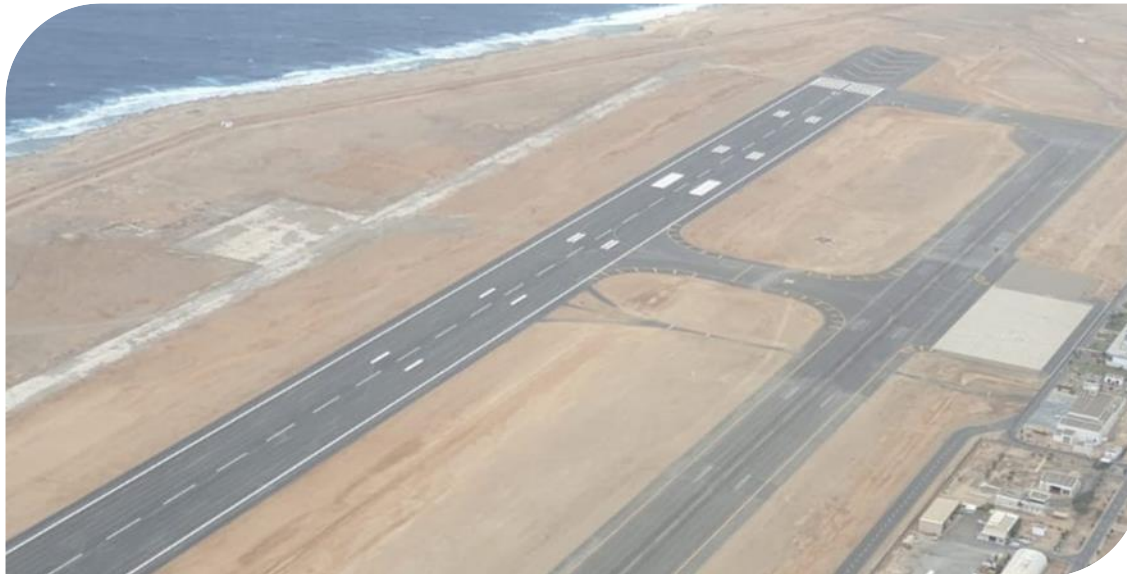
Figure 3: Closed Taxiway

On 26 February 2019, a Saudi ARAMCO B737-800 aircraft, registration N803XA, scheduled for a three-sector flight that started from King Fahd International Airport (OEDF), Dammam, to Arar Domestic Airport (OERR), then to Al Wajh Domestic Airport (OEWJ) and then back to OEDF. On the second sector from OERR to OEWJ, the flight crew landed on the closed Taxiway-A (previously Runway-15T), the last sector back to OEDF was canceled and the AIB requested the Cockpit Voice Recorder (CVR) circuit breaker to be pulled. No injuries reported as a result of the occurrence. Overall, a number of safety concerns were identified during the course of the investigation, these concerns included the flight crew's lack of knowledge and/or understanding of the issued NOTAMS of the reopening of RWY-15, the closure of TWY-A, the closure of apron 1, and the cancellation of the RNAV approach for Runway-15T. Additional deficiencies with the dispatcher pre-flight briefing were observed. The flight crew selection and execution of the canceled RNAV approach for RWY-15T restricted to VMC conditions was recorded by the FDR and CVR. Safety recommendations addressing operating procedures and training were issued to the operator.

1 AIB-2019-0034-SR-01

Saudi ARAMCO Aviation Department to introduce risk controls, ensuring procedural items of primary importance (4.6.1 of ARAMCO's FOM) are effectively followed during the preflight aircrew briefing.

2 AIB-2019-0034-SR-02

Saudi ARAMCO Aviation Department should revisit its Crew Resource Management (CRM) training program to ensure the effectiveness of the "Trans Cockpit Authority Gradients" and disseminating the lessons learned.

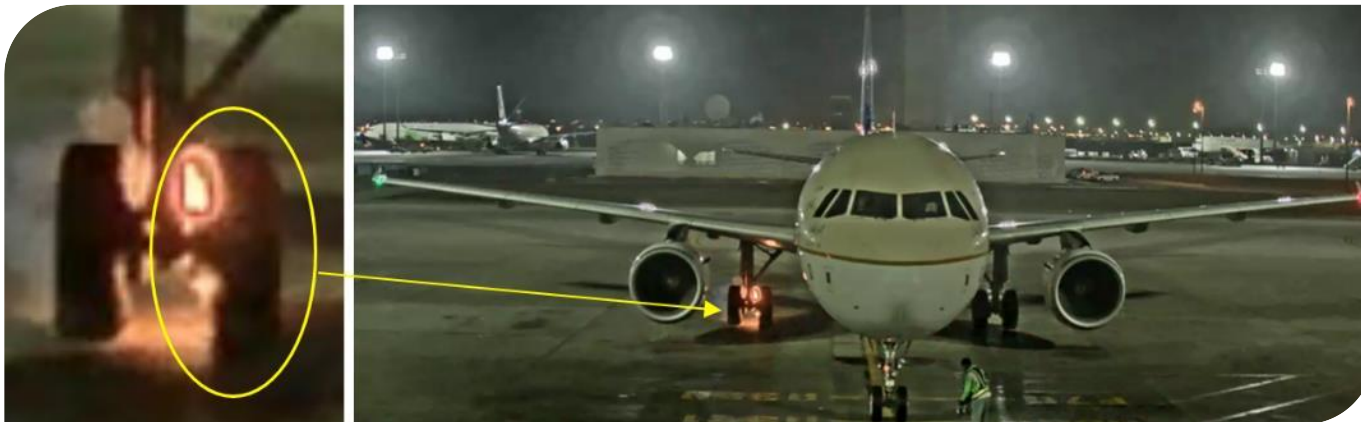
Figure 4: A320-211 fire on the right main landing gear

On 22 December 2017, Saudi Arabian Airlines, Airbus A321-211 aircraft, with registration number HZ-ASQ, was operating a scheduled passenger flight number SVA501, from Kuwait International Airport (OKBK), State of Kuwait, to King Abdul-Aziz international airport (OEJN), Jeddah, Kingdom of Saudi Arabia. HZ-ASQ landed safely on runway (RWY) 16R and taxied to the assigned parking stand at apron number (3-9). While the passengers were still on board the aircraft, the ground services staff tasked to place the parking chocks at nose landing gear observed fire on the right main landing gear. Initial firefighting was done by the Saudi Ground Services (SGS) staff. The Fire and Rescue Services (FRS) arrived at the aircraft stand, put out the fire, and restored the condition to normal. The passengers were deplaned safely using air stairs connected to L1 door. No injuries were reported as a result of this incident. The causal factor of the brake fire incident could not be specifically determined. However, it is most likely the ruptured tie-bolt head was the trigger that started a chain of events of breakage and failures of parts and systems that ended with brake fire. During the progress of this investigation, a number of safety findings were observed and were communicated with the Operator, the MRO, and the FRS, launching corrective and preventive actions to prevent or mitigate reoccurrence of similar incident, such as:

- The Operator mandated performing a Non-Destructive Testing (NDT) on MLG wheel tie-bolts at every shop visit.
- MRO Shop technicians received vendor onsite training to improve their performance (including but not limited to tie-bolt maintenance handling process).
- The Technical Services Training Department released Training Bulletin number 431, dated 06 November 2019, as an awareness tool for addressing the tie-bolt installation requirements and standard practice.
- FRS management issued and circulated an instruction letter to all staff, to strictly adhere to established safety standards and procedures whenever responding to any emergency situation, as outlined in the Standard Operating Procedures (SOP).

The AIB issued a recommendation to the operator of performing a reliability study on current fleet, to test the performance of landing gear wheels and brakes consumable parts.

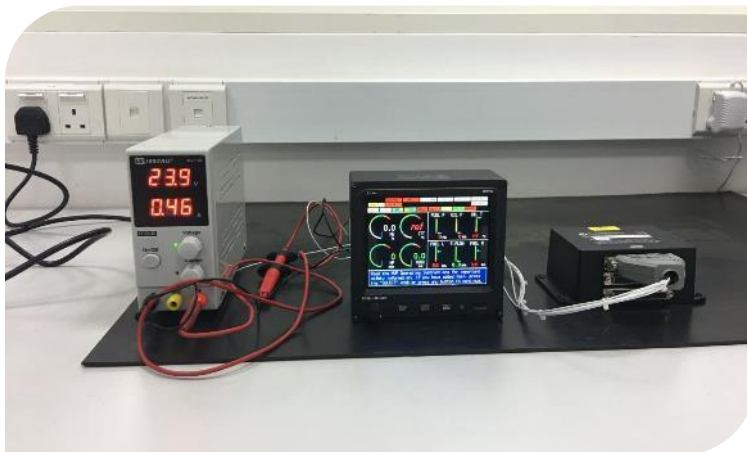
Figure 7: MVP-50T connections for download

MVP-50T is a Glass Panel Engine Monitor for Turboprops/Jets. The primary purposes of the device is to replace a number of aircraft gauges and to perform several functions related to the fuel, engine, balance and others. The device is also capable of recording several critical information about the aircraft and the flight, which makes it a useful evidence and source of factual information for the investigations. The importance of developing the means for its readout is especially important as the device is commonly found in general aircraft types that do not require flight recorders, hence, potentially becoming the sole source of the recorded factual information on these aircraft. The AIB has developed the means required to readout the device which include the utilization of additional component that establishes an imitated oil pressure connection to allow the download to be conducted. Newer models of the device do not require such connections anymore. Instead, a programmable pin is programmed to allow the download. This development will surly contribute to the expansion of the capabilities for similar general aviation devices in the future.
